Manhole Inspection Summary

Manhole # S21C__032MH

Insp Date: **4/6/09 1:45 PM**

Location Address: **MONROE ST**

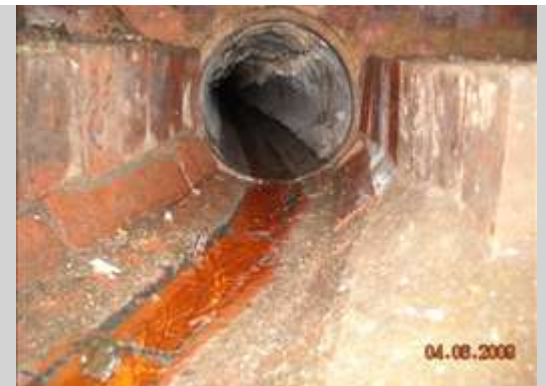
7 O'Clock Inflow

8 in. Circular Gravity Sewer
Pipe In @ 7 O'Clock

Pipe Height: **8.4** (in.) Rod and Bar (Angled)
Pipe Material: **Clay** ☐ Pipe Lined
Invert Depth: **8.00** (ft.) Flow Characteristics: **Slow**
Deposits: ☒ **None** ☐ **Mud** ☐ Sludge ☐ Debris ☐ Grease
Silt Depth: (in.) Deposits Extent:
Infiltration: **None** Pipe Seal Cond: **Sound**
